Race Tech brake arcing and Pecard leather care

Race Tech brake arcing service

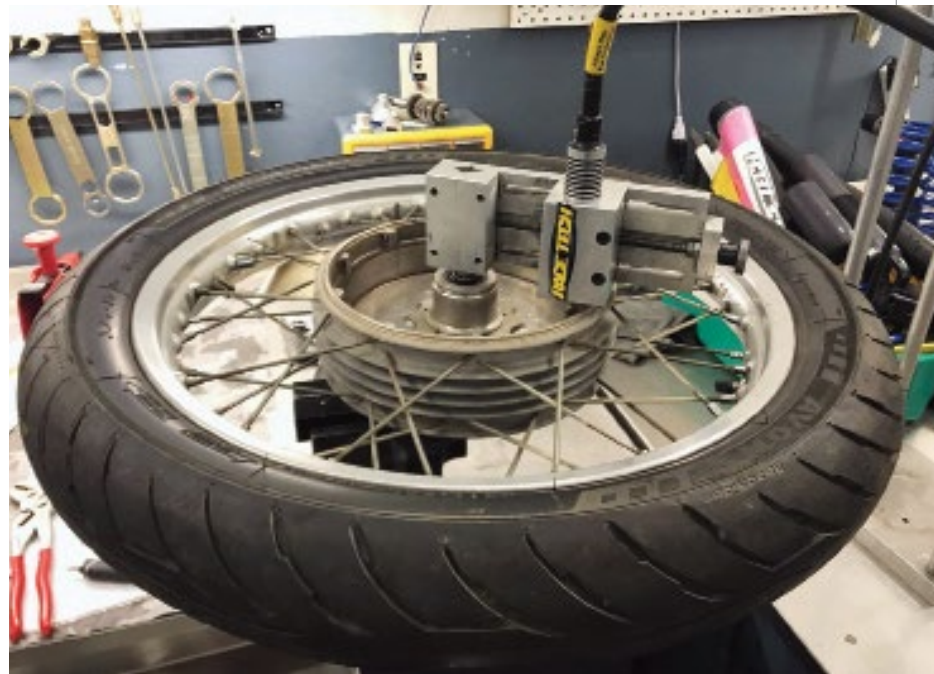
Race Tech's proprietary tool in place to machine the 1973 BMW R75/5 front drum.

At Race Tech, the wheel is set in a work stand supported by its axle. The inside face of the drum is then marked with black squiggly lines. Next, a specially made cutting tool designed by Race Tech founder Paul Thede is centered on the wheel axle. An air-powered rotary cutting head attached to the tool is adjusted to just touch the drum face. As the cutting head spins, the tool slowly revolves around the drum,

the cutter removing metal as it does. The black squiggles act as a guide, showing high spots as material is removed; wherever black still shows, the drum hasn't been cut. This is done in multiple passes, the cutter removing as little material as possible with each pass until a clean surface remains.

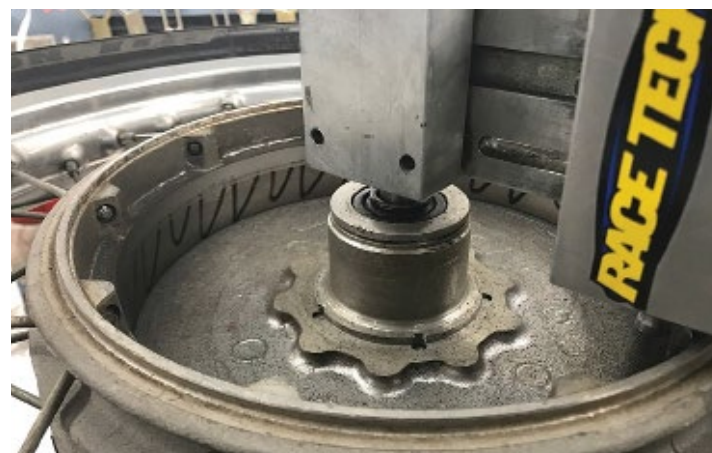
Black lines act as cutting guide; when they're gone, the drum's done.

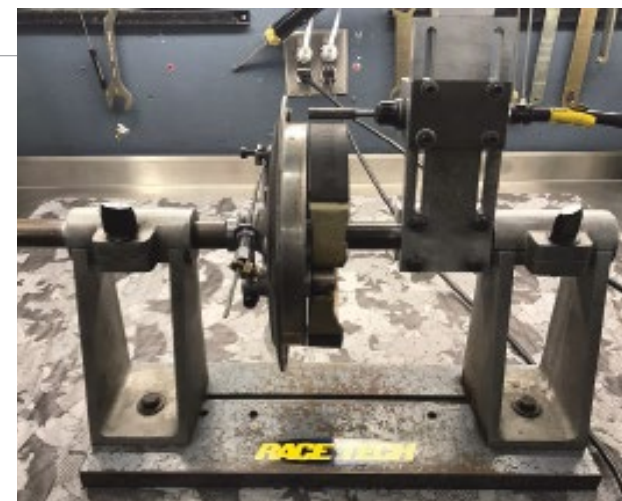
Brake backing plate with shoes jugged up on Race Tech's brake arcing tool to cut and match the profile of the shoes to the drum.

The shoes are cut next. In this step, the shoes — complete with backing plate — are held in place while another rotary cutter, set up to exactly duplicate the arc

and diameter of the cut on the drum, matches the cut to the shoes, ensuring the shoes are exactly concentric to the drum. Simple in concept, it takes the right tools and skill to do it correctly.

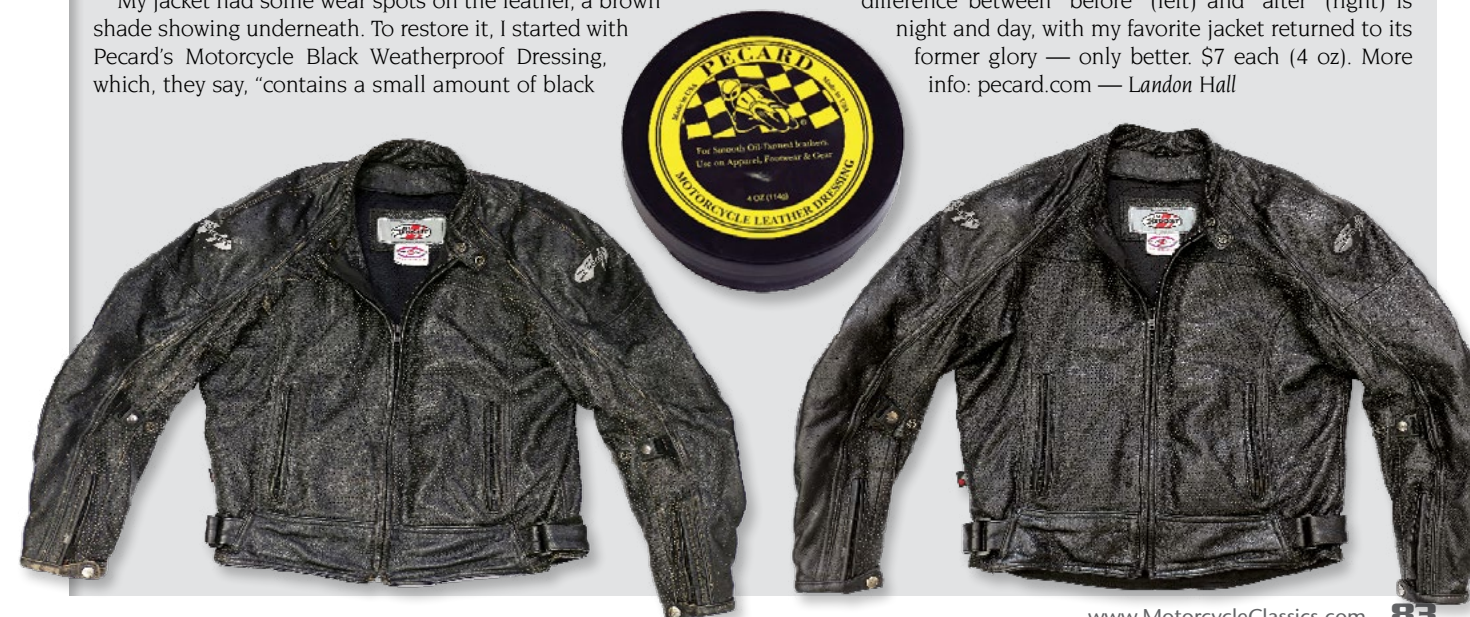
My jacket had some wear spots on the leather, a brown shade showing underneath. To restore it, I started with Pecard's Motorcycle Black Weatherproof Dressing, which, they say, "contains a small amount of black

tint" to cover up abrasions. After lightly cleaning the leather with a damp cloth, I applied the dressing using a soft, dry cloth, working it into the leather. The dressing did wonders. Not only did it re-dye the rough edges and worn cuffs, it restored the sun-faded jacket to an even coloring again. As a further bonus, it also moisturized the leather, making it softer and suppler.

After letting the jacket "dry," the dressing soaked in nicely. I figured it could use one more coat, so for round two I used Pecard's standard Motorcycle Leather Dressing, applying it outside and in the sun on a 65 F day, letting the leather warm up and really soak in the dressing. I put on a heavy coating, and then hung it inside to soak in for a few more days. As the photos show, the difference between "before" (left) and "after" (right) is night and day, with my favorite jacket returned to its former glory — only better. \$7 each (4 oz). More info: pecard.com — *Landon Hall*
